# Bridge Inspection Report

## Weir Road Bridge

**Road Name:** Weir Road  
**Site ID:** EC1  
**Structure Type:** Slab on Prestress Girder  
**Owner:** Edwardsburgh Cardinal  
**Built:** 1983  
**Length:** 27.4 m  
**Width:** 9.8 m  
**Spans:** 1  
**Spans Arrange:** 1 @ 27.4  
**Feature Under:** Navigable Channel  
**Crossing:** South Nation River  
**Location:** 450m north of Cnty Rd 21  
**Inspection Date:** May-24-22  
**Inspector:** Steve Reid, C.E.T.  
**Assistant:**

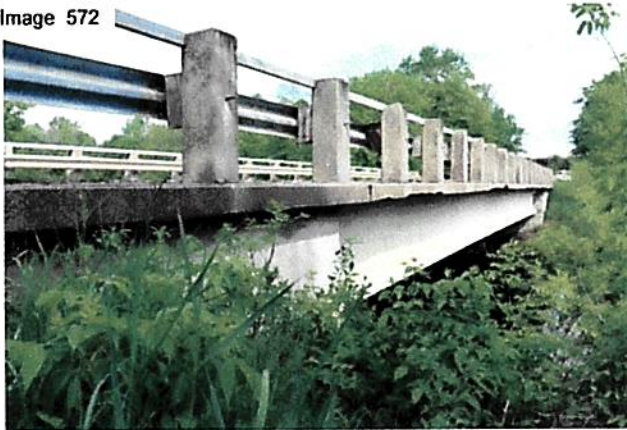
Image 572

East elevation

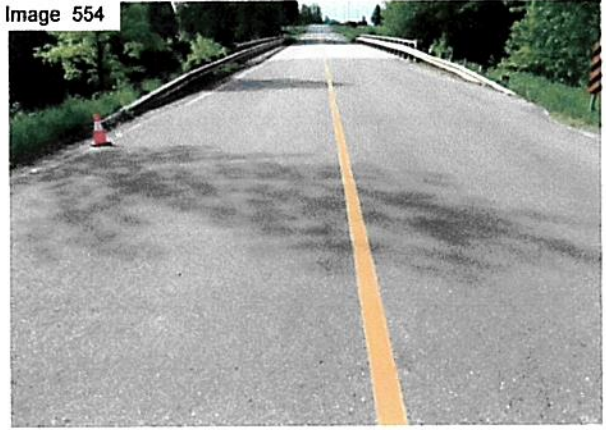
Image 554

| <b>Asphalt Wear Surf (2)</b><br><b>Approach Wear Surf</b> | <b>Defects</b> 0.0% <b>Moderate Ravelling</b><br><b>Damage</b> 1.0% <b>Minor Cracking</b><br><b>Maintenance</b> None<br><b>Capital Rec.</b> None<br><i>North approach has been renewed since 2019. The south side is acceptable.</i> |

South approach

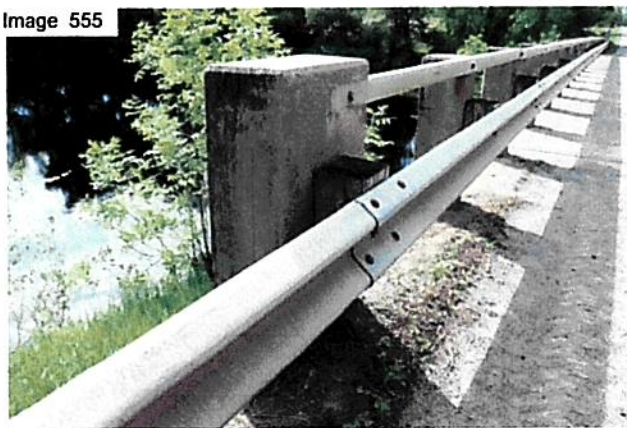
Image 555

| <b>Timber Post &amp; Guide Rail (4)</b><br><b>Approach Barrier</b> | <b>Defects</b> 0.0%<br><b>Damage</b> 15.0% <b>Moderate Decay, Minor Impact</b><br><b>Maintenance</b> None<br><b>Capital Rec.</b> Replace in 2 years <b>Perf Def: Does'nt Meet New Standard</b><br><i>Approach guide rail is generally in good condition with some minor vehicle scrapes. The wood posts and spacer blocks are in varied states of decay with local replacement required. Buried end treatments do not meet the current standards. Guide rail is overgrown with vegetation.</i> |

Guide rail and posts

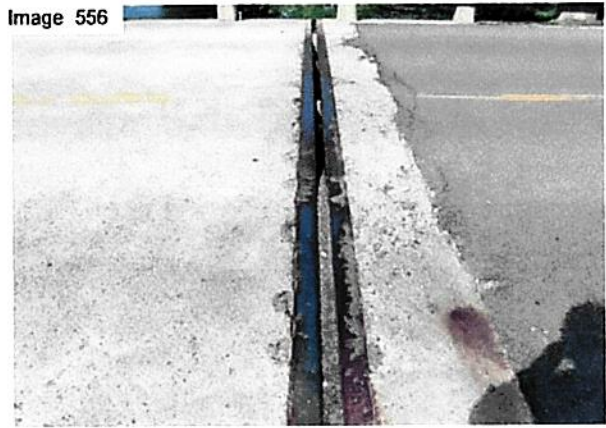
Image 556

| <b>X- Joint Conventional (2)</b><br><b>Expansion Joints</b> | <b>Defects</b> 10.0% <b>Minor Scaling/Abrasion</b><br><b>Damage</b> 80.0% <b>Major Torn/Perforated Seal</b><br><b>Maintenance</b> None<br><b>Capital Rec.</b> Replace in 1 year<br><i>North &amp; south seals are both detached. Debris is spilling onto bearing seats. Tops of ballast walls &amp; end dams have minor spalling/delaminations along armouring.</i> |

North expansion joint typ.

Both expansion joint seals should be replaced as soon as possible to prevent further damage to the girder ends and abutment walls. It is recommended that this bridge receives a major rehabilitation within 2 years time. Semi-integral conversion should be considered at time of rehab.

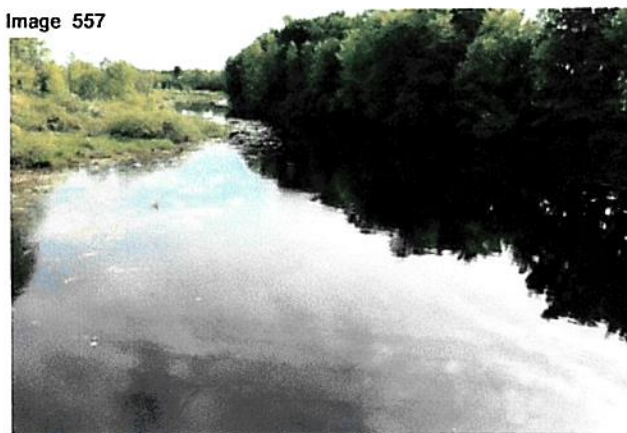
Image 557

Downstream channel

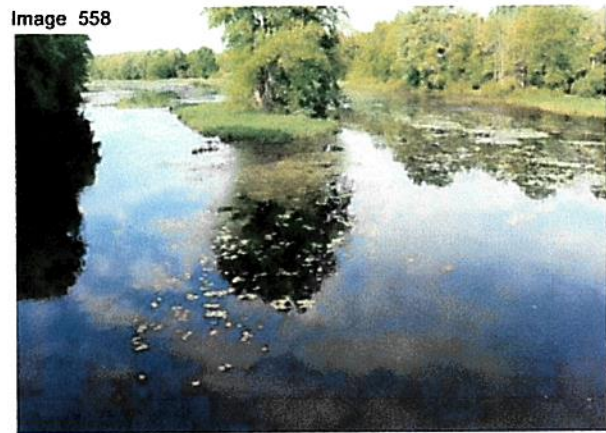
Image 558

Upstream channel

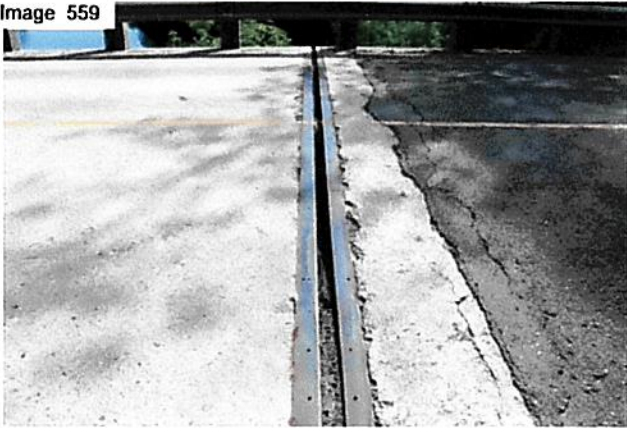
Image 559

South expansion joint

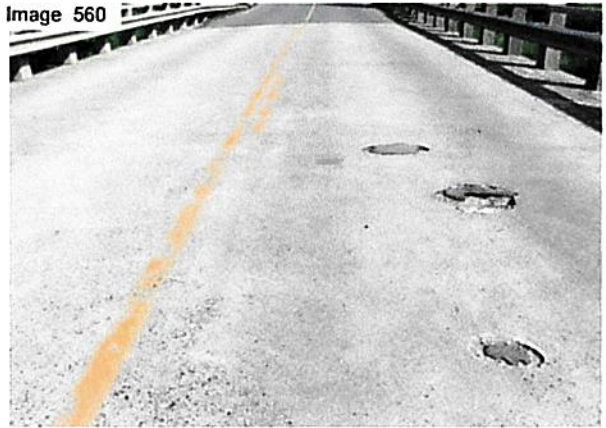
Image 560

Asphalt on deck typ.

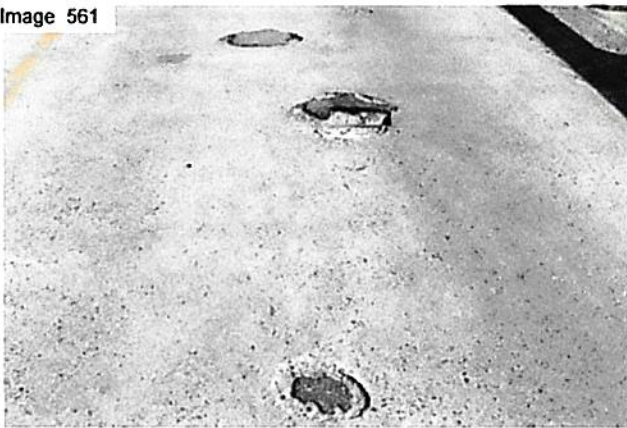
Image 561

| <b>Unprotected BSRC Deck (1)</b><br><b>Deck Surface</b> | <b>Defects</b> 40.0% <b>Minor Scaling, Moderate Scaling, Moderate Polished</b><br><b>Damage</b> 7.0% <b>Moderate Delamination, Moderate Spalling</b><br><b>Maintenance</b> None<br><b>Capital Rec.</b> Repair in 2 years<br><i>No tining present on deck surface. Deck has minor scaling throughout &amp; minor delaminated areas. Delaminations predominantly in the northbound lane (East side). Sandy fine granulars accumulating on shoulders on deck, mainly east side. Chain drag in 2022 confirms previous findings.</i> |

Close-up deck damage

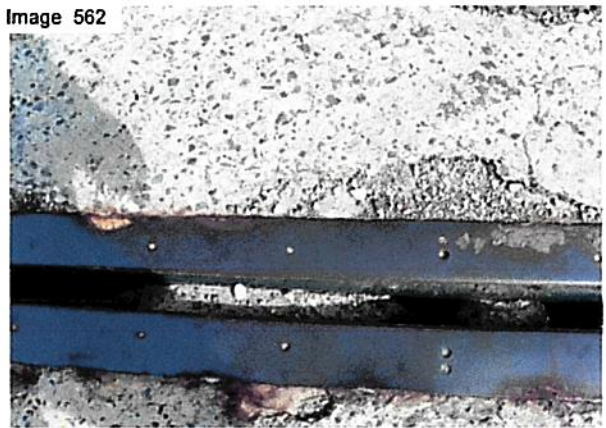
Image 562

Close-up north expansion joint seal torn

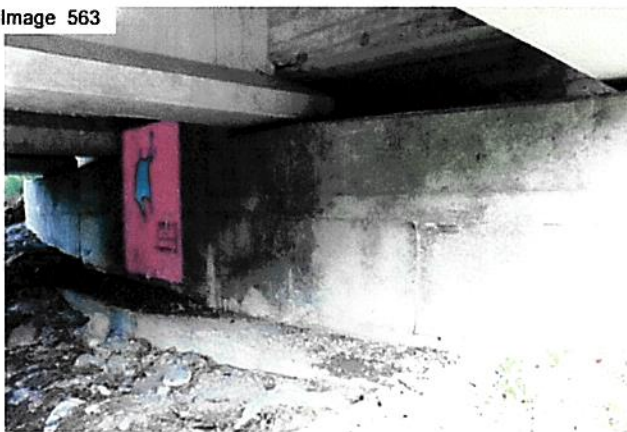
Image 563

| Height: <b>1.3 m</b> | <i>Moderate delaminations detected on both abutment walls. Debris is accumulating on the north &amp; south bearing seats due to the detached expansion joint seal. Fire pit noted at the north side (noted 2019).</i> | |

North abutment

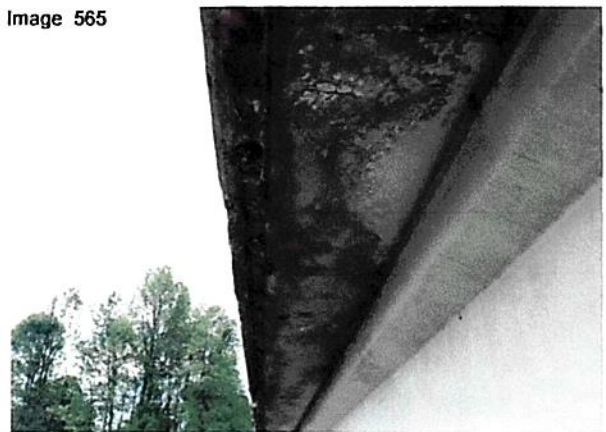
Image 565

| <b>Soffit (1)</b><br><b>Deck Soffit</b> | <b>Defects</b> 10.0% <b>Minor Staining, Minor Scaling, Minor Leaching/Seepage</b><br><b>Damage</b> 5.0% <b>Moderate Delamination, Moderate Spalling</b><br><b>Maintenance</b> None<br><b>Capital Rec.</b> Repair in 2 years<br><i>The soffit interior is in good condition. One damp area noted near the SE end. The exterior edges are spalled due to the lack of curbs or drainage present on deck. Utility attached to the west side.</i> |

NE deck soffit spalling

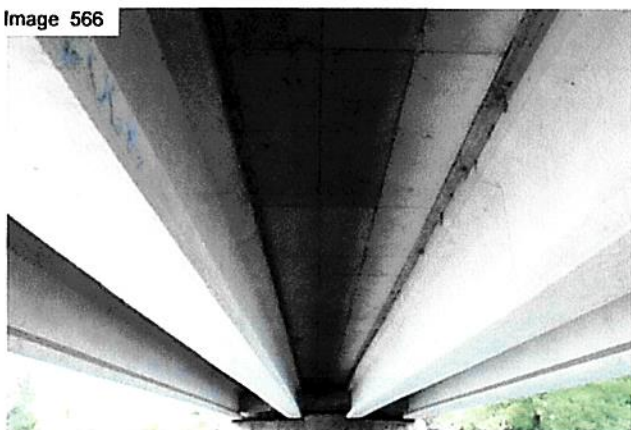
Image 566

Soffit center span typ.

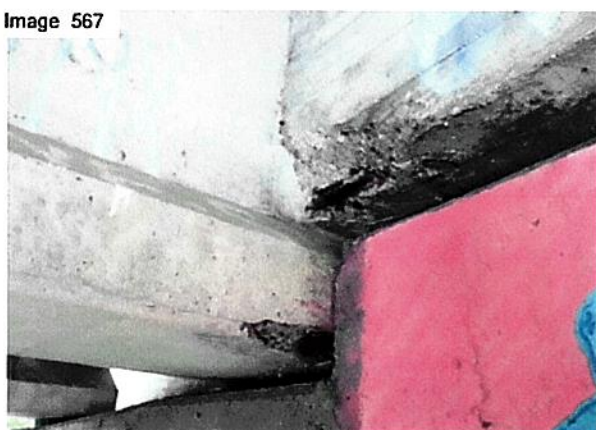
Image 567

| Height: <b>1.44 m</b> | <i>Girders are generally in good condition. Girder ends have developed minor delaminations &amp; spalls due to the detached expansion joint seals. Bottom of girder, 2nd from west at south end has a moderate spall near bearing.</i> | |
| Height: <b>0.8 m</b> | <i>Diaphragms have minor cracking &amp; delaminations. Notably at the shear key at north end.</i> | |

Diaphragm and girder north end damage

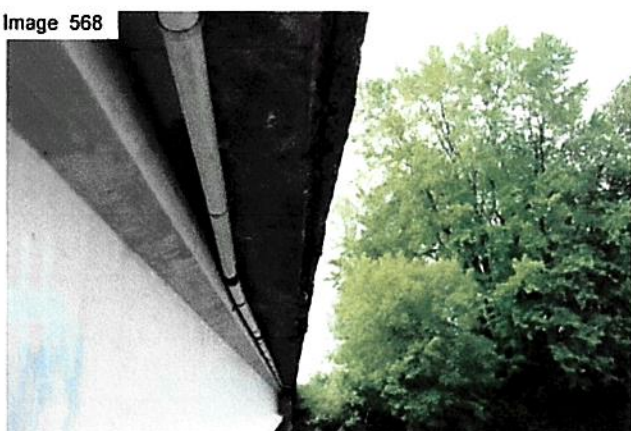
Image 568

West side soffit spalling

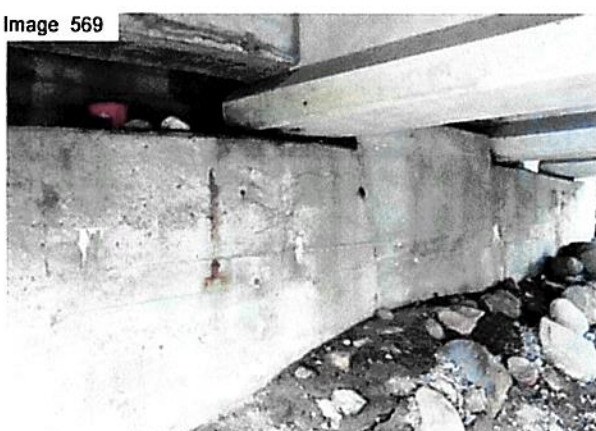
Image 569

South abutment

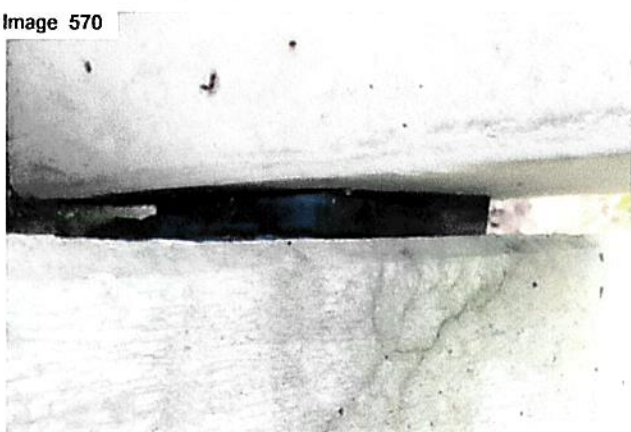
Image 570

| Height: | | <i>Bearings appeared in good condition. Some debris is accumulating around bearings due to the failed joint seals.</i> | |

Bearing typ.

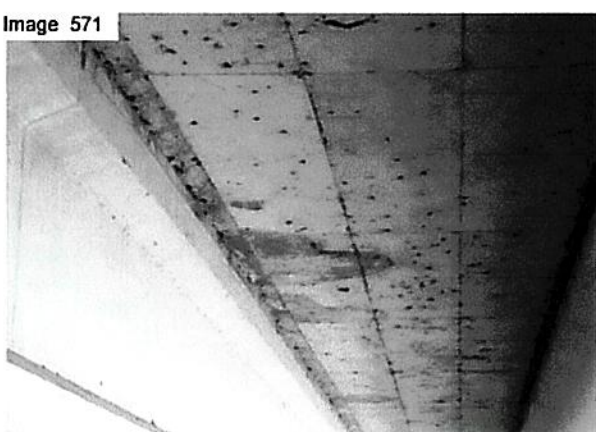
Image 571

Damp area on soffit
