**RE: Inspection of Culvert at 515 County Road 21 (Dewitt Richter MD)**

**Client Name:** Township of Edwardsburgh Cardinal

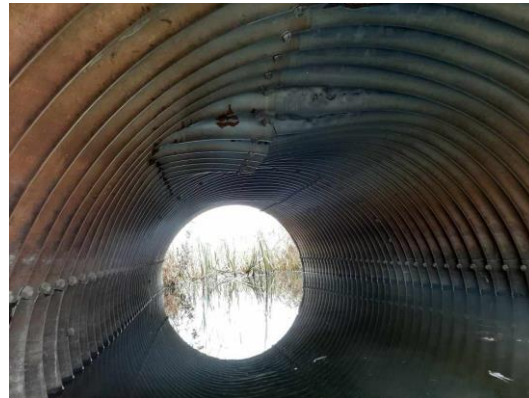
In the Fall of 2023, Greer Galloway completed a review of the existing farm crossing culvert at 515 County Road 21. Before the site visit, we contacted the homeowner, Mr. Sean Luimes. We had been informed by the property owner that the culvert began to collapse during normal operations when he attempted to cross it with a spreader. After the damage Mr. Luimes stopped using the access. The damage can be seen in Fig 1.

*Fig 1: Damage to Culvert*

It is our recommendation that this culvert be replaced and that it be closed until replacement can occur. This culvert can be replaced like for like with a CSP culvert but OPSD 805.010 for height of fill must be followed to ensure that the culvert will function properly. A culvert of this size will require 400-450 mm of cover depending on the type of CSP.

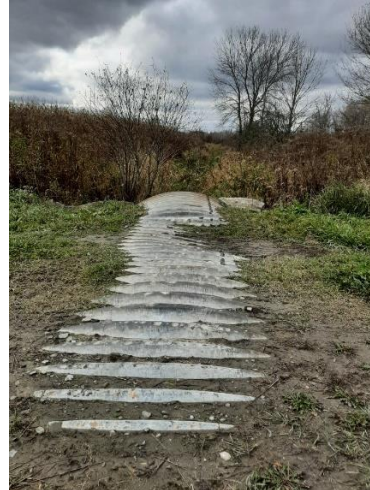
During the inspection it was found that the culvert was not installed properly and had zero cover as shown in Fig 2 below. At the time of installation this would have met the needs of property owners, but due to the increase in size and weight of modern farm equipment this is no longer sufficient. During the site visit it was confirmed that the damaged culvert is along the Dewitt Richter Municipal Drain just prior to its intersection with the James Reilly Main Municipal Drain.

*Fig 2: Cover Over Damaged culvert*

In addition to the replacement of this culvert we recommend that all Municipal Drain culverts be checked to ensure that minimum cover is provided. This would be considered preventative maintenance to mitigate future damage.
