**EDWARDSBURGH COMMUNITY CENTRE**

**STRUCTURAL REVIEW**

**ARENA BUILDING**

**July 2022**

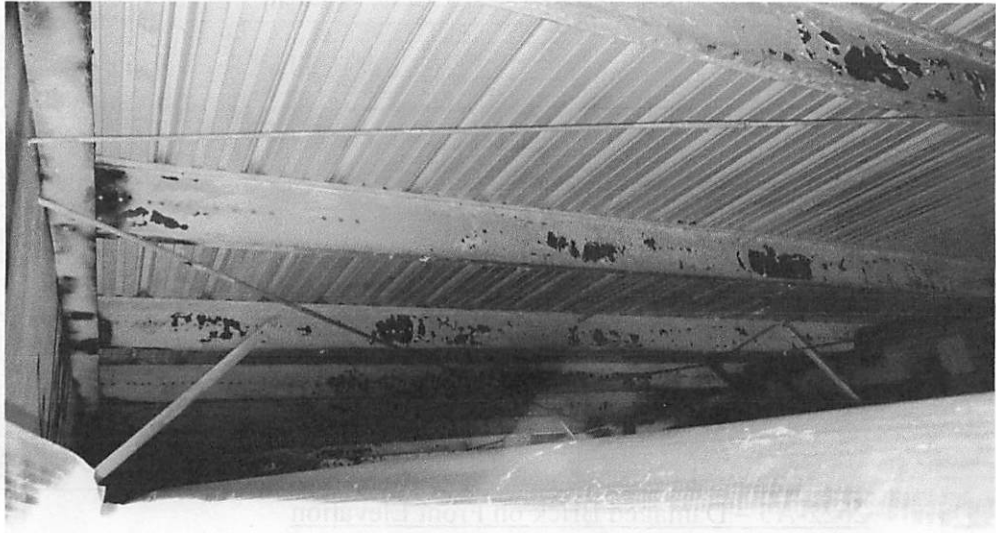
The roof purlins spanning between the main structural frames are of cold-formed light gauge steel material and appeared to be in reasonably good condition. Our 2017 report noted that some areas of paint peeling were observed, and maintenance of these areas was recommended. The paint peeling from surfaces of the roof purlins now appears to be a general condition (photos 2022-A3 & A4) and, again, maintenance and recoating is recommended. This, however, has not yet had a detrimental effect on the structure.

2022-A3 – Paint peeling from Roof Purlins

1. Provide maintenance and recoating to the areas of paint peeling or surface rusting on steel roof structure components.
2. Ensure that signs prohibiting the gathering of people on the walkway to the second floor are installed and clearly visible.
3. Consider repainting of the rust areas on the exterior siding.
4. Repair brickwork as noted.

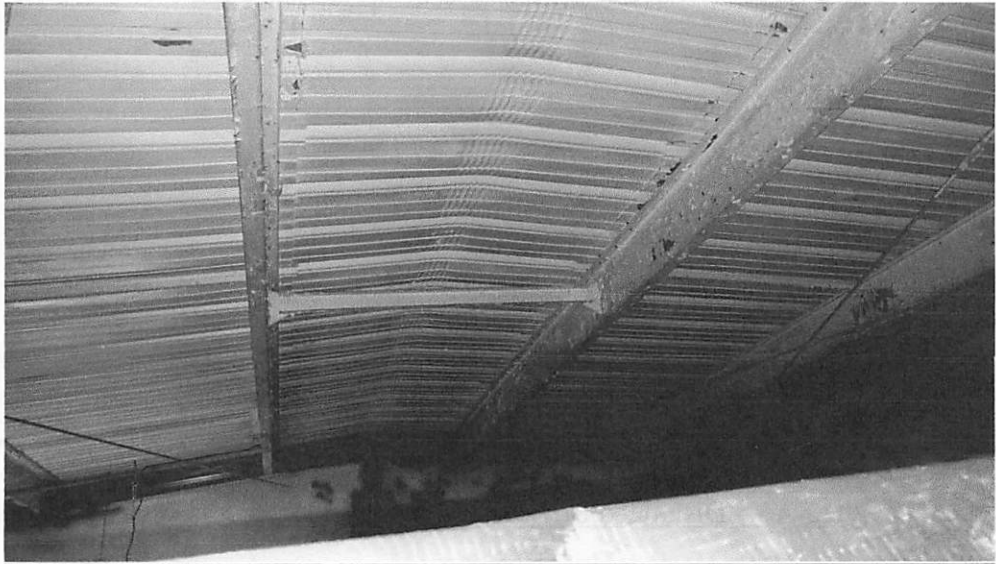
2022-A4 – Paint peeling from Roof Purlins and Main Girder

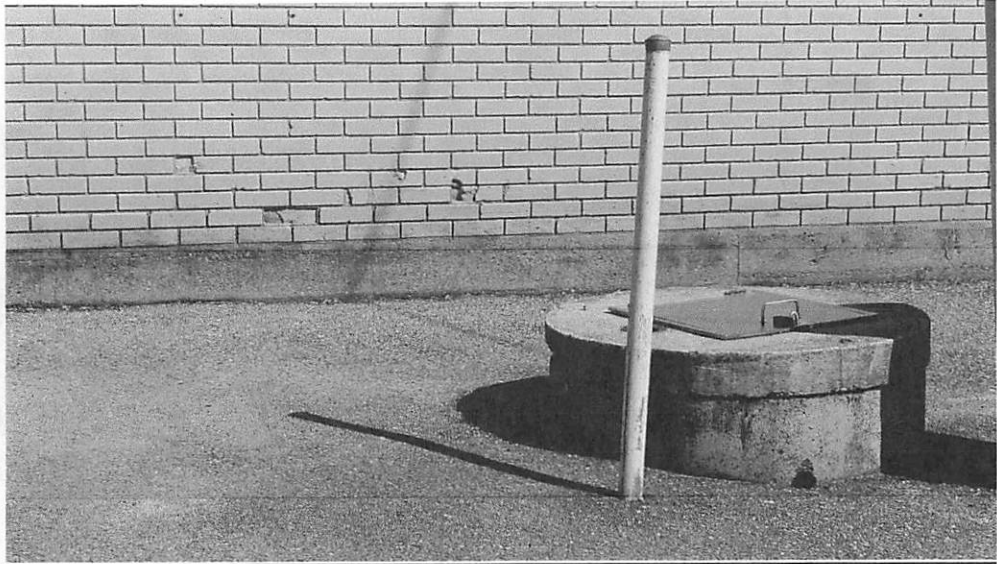
The structure for the front lobby was reviewed and found to be in good condition with no significant indication of deficiency. Specifically, no cracking, settlement or movement was observed in the concrete block walls thus indicating good performance of the foundation elements. The exterior brickwork is generally in good condition although some aged areas were observed on the front elevation (photo 2022-A5) and one brick has become dislodged at the south-west corner (photo 2022-A6). The damaged areas should be repaired with epoxy mortar fill and the dislodged brick should be appropriately reinstalled.

2022-A5 – Damaged Brick on Front Elevation

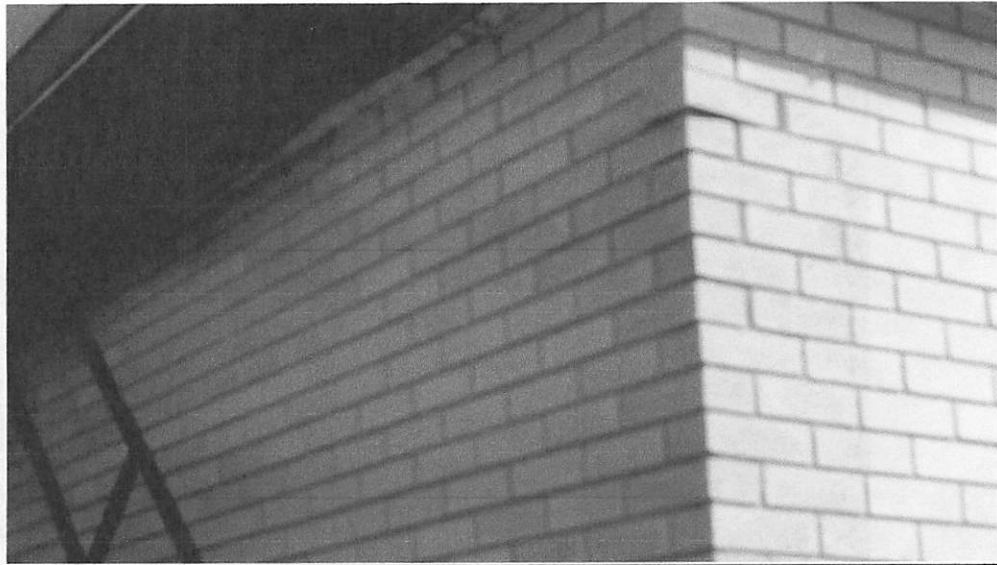
2022-A6 – Dislodged Brick at South-West Corner
