**THE TOWNSHIP OF EDWARDSBUGH/CARDINAL  
DEVELOPMENT AGREEMENT**

**DEVELOPMENT AGREEMENT  
BETWEEN EDWARD AND LILA BRONISZESKI  
AND THE TOWNSHIP OF EDWARDSBURGH/CARDINAL**

**SCHEDULE "C"**

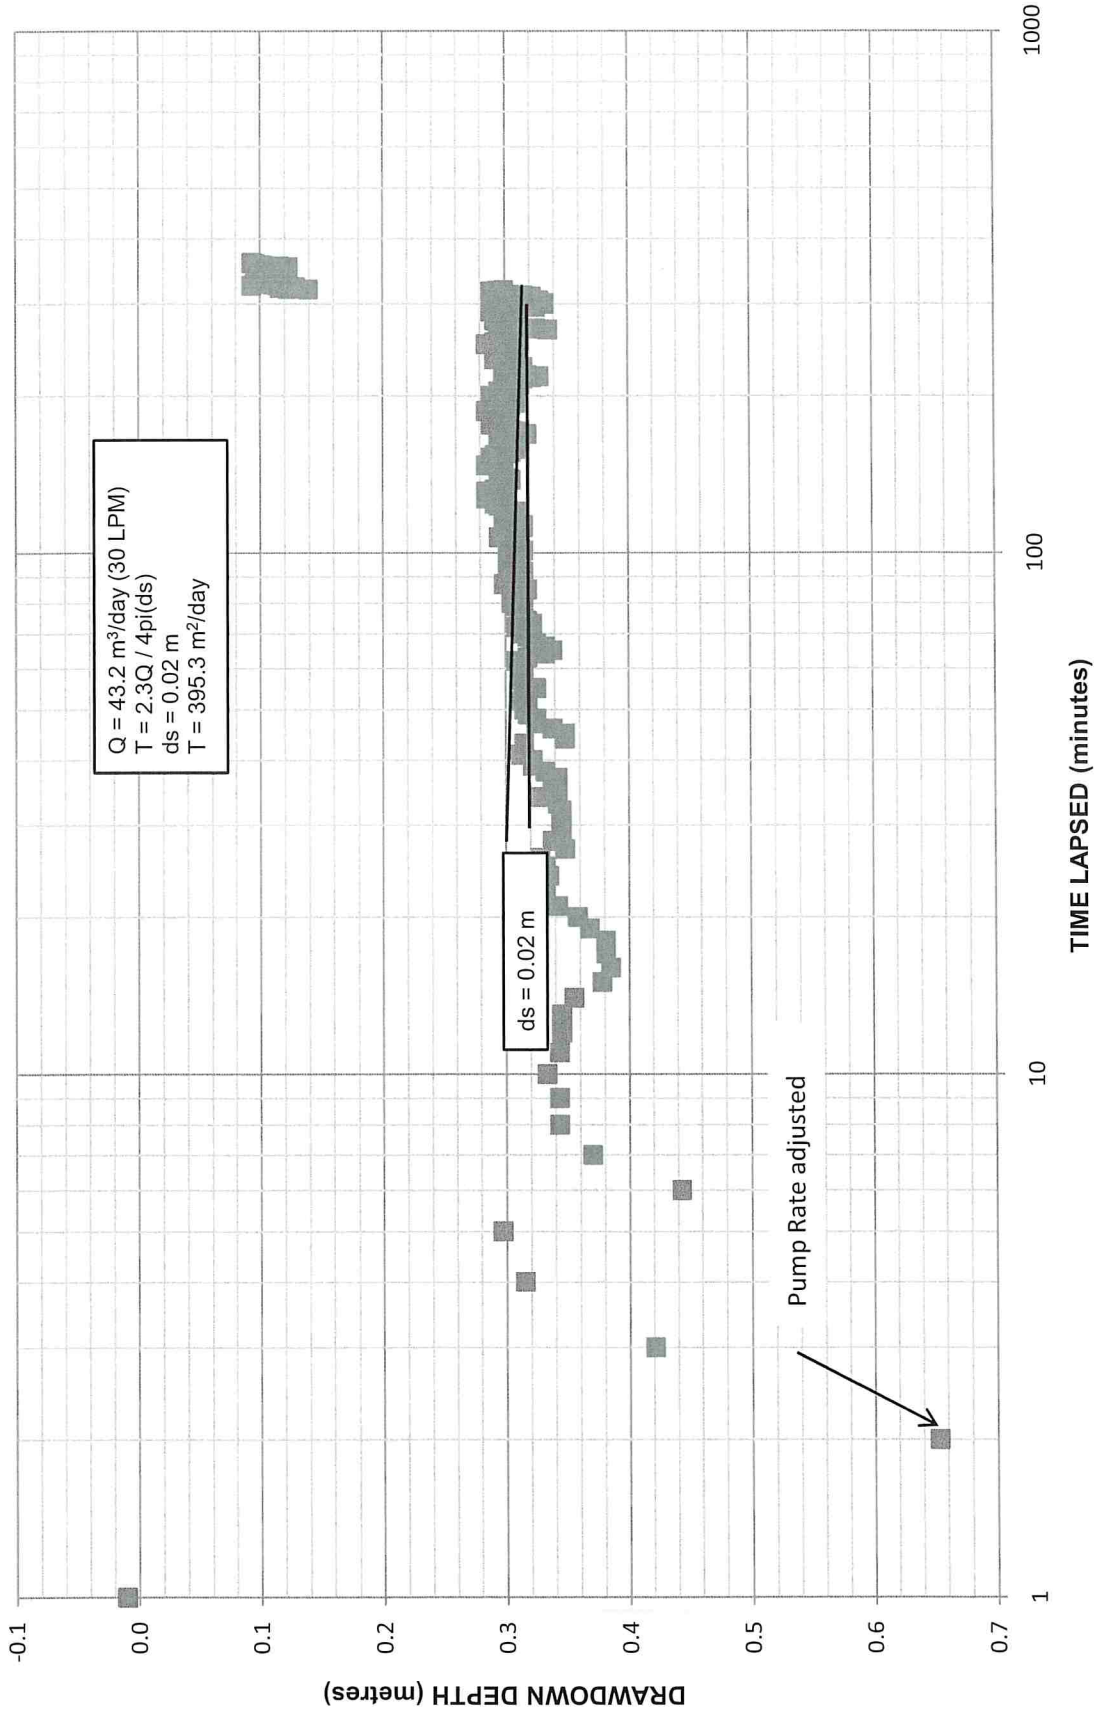
TW1-WELL DRAWDOWN VS. TIME-KOLLAARD FILE 220996

**DRAWDOWN DATA TW1**

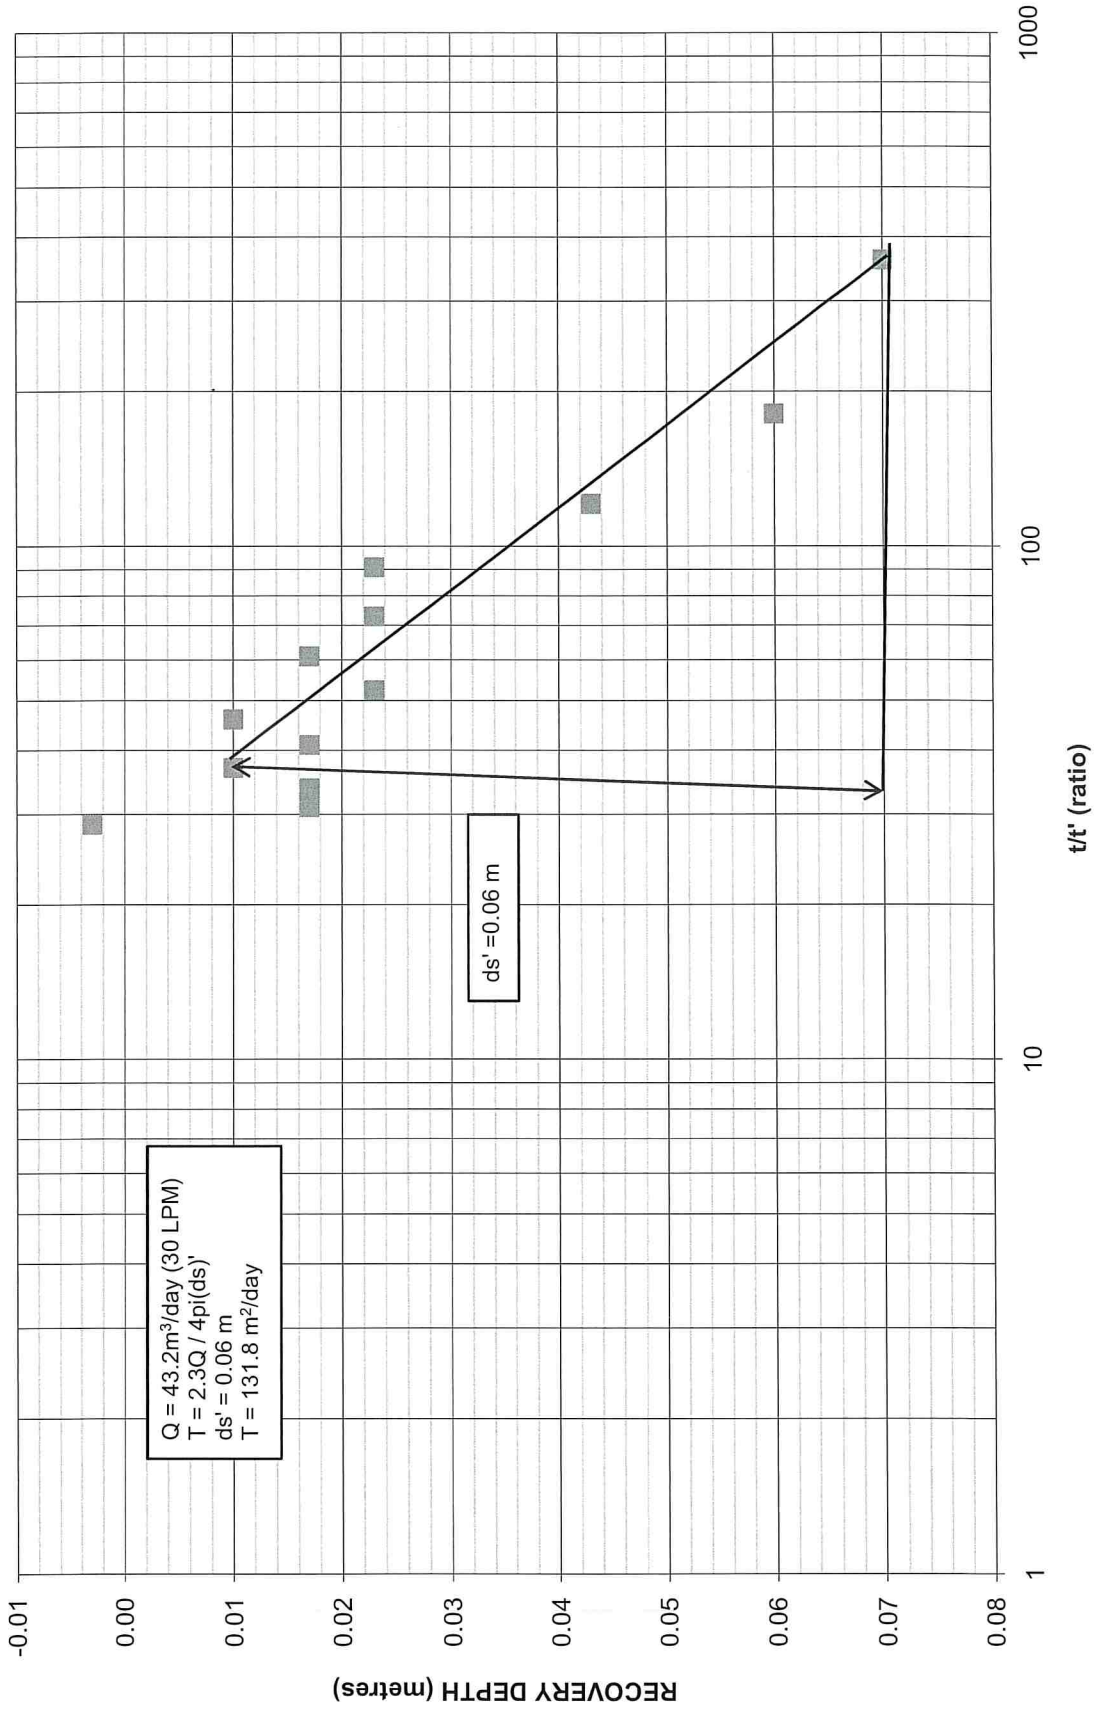
TW1 - WELL RECOVERY VS. TIME - KOLLAARD FILE 220996

**RECOVERY DATA TW-1**
