**St. Lawrence Testing
& Inspection Co. Ltd.**

**RE: Bobby Leeder Property, Cardinal, ON
Additional Geotechnical Data
Report No. 22C004**

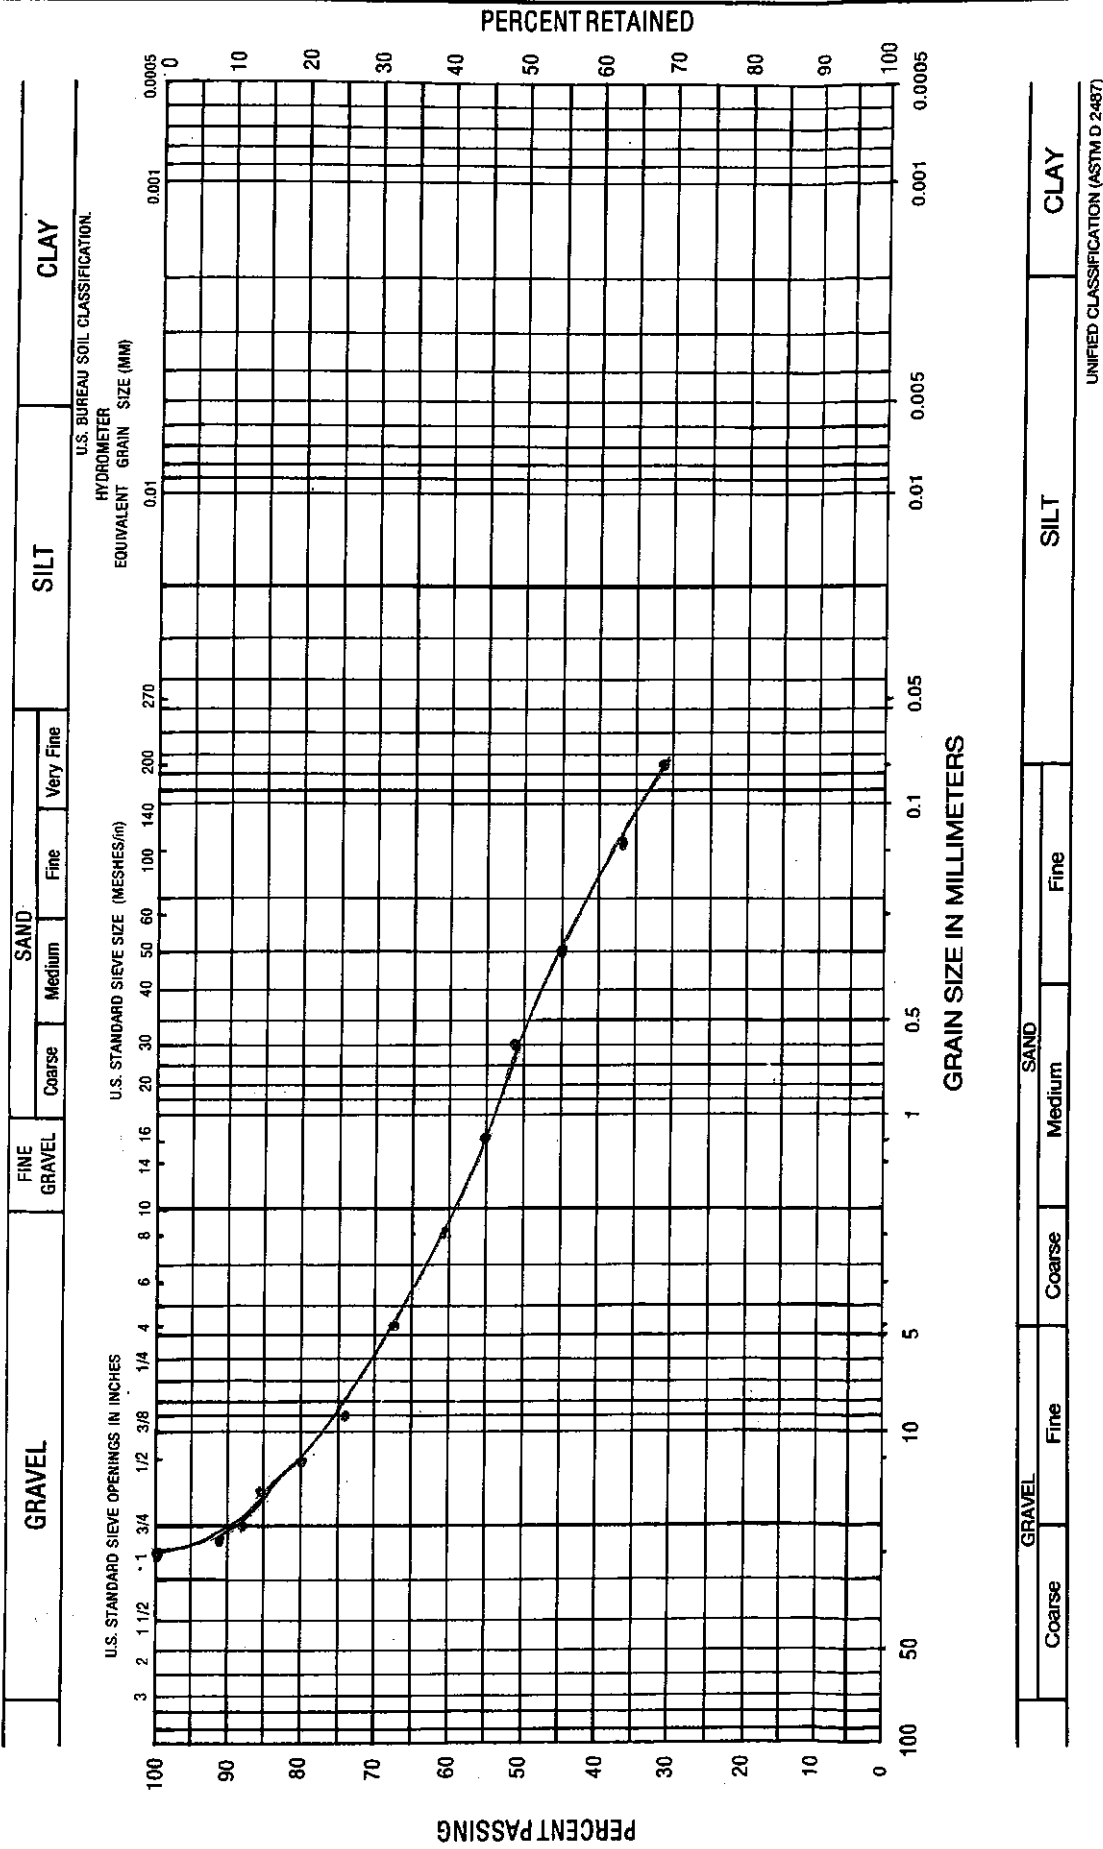
BOREHOLE No. 2

SAMPLE No. 2

DEPTH 5 - 7 ft.

DESCRIPTION Sand and gravel with silt

The fill at Borehole 2 was the same sand and gravel with silt fill as noted at Borehole 1. However, it extended to 2.28 m. Below 2.28 m. was a brown, very moist loose silt with sand and clay fill that extended to 3.60 m. Below 3.60 m. was a grey, moist, firm silty clay that became wet and soft below 7.5 m. We advanced the borehole by driving down a penetration cone to the top
